Doire-  
chlaigionn

Centred on NG  
82575 54783

# Doire-chlaigionn centred on NG 82575 54783

This settlement is situated on an E facing slope leading down to Ob Mheallaidh on Upper Loch Torridon and to the NE of the village of Shieldaig.

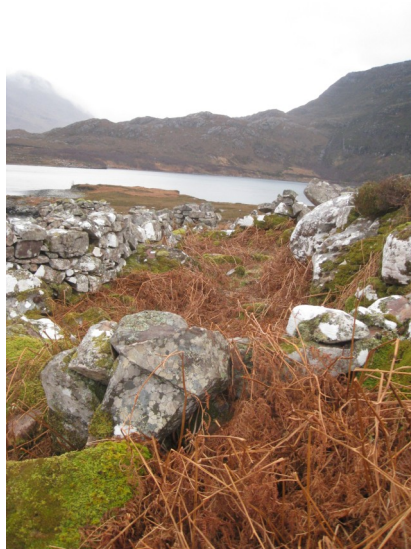
9. cont

Small building to the rear built into the slope.

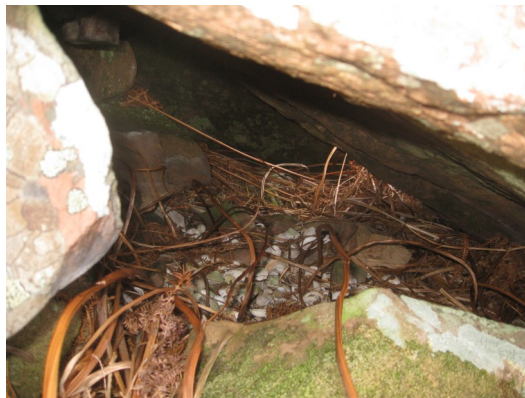
Just beside this ruin under a boulder there is a shell midden

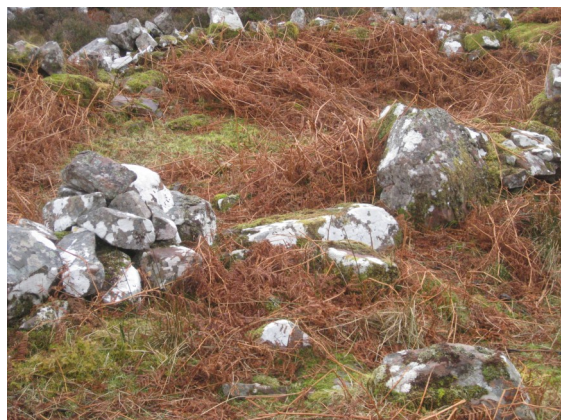
10. A roughly constructed one compartment ruin, probable barn/byre with entrance.  
NG 82590 546 99 18m

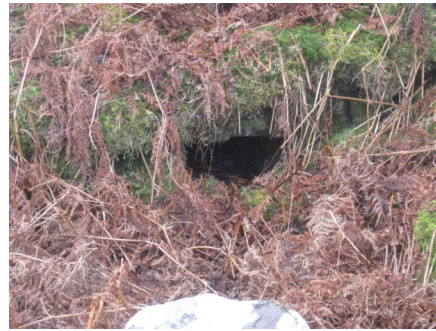
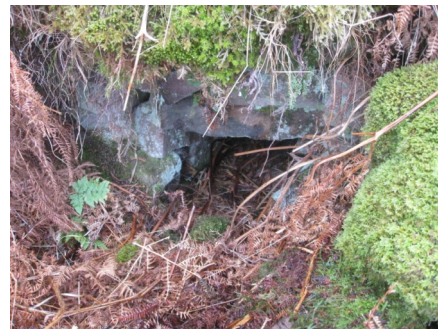
11. Corn drying kiln that is built into the crag. It has two flues into the bowl from the attached kiln barn, depending on direction of wind as to which would be used. The bowl s filled in with debris. NG 82545 54704 elevation 21m

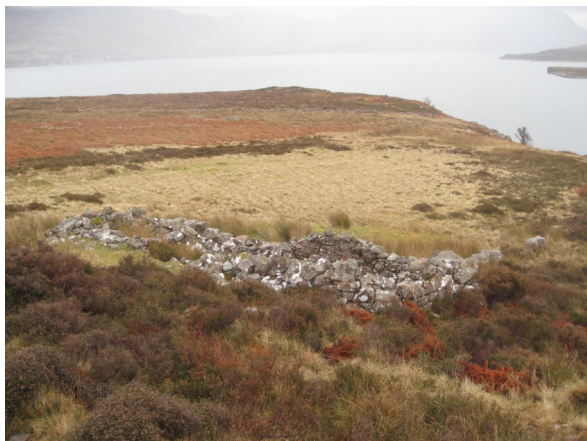
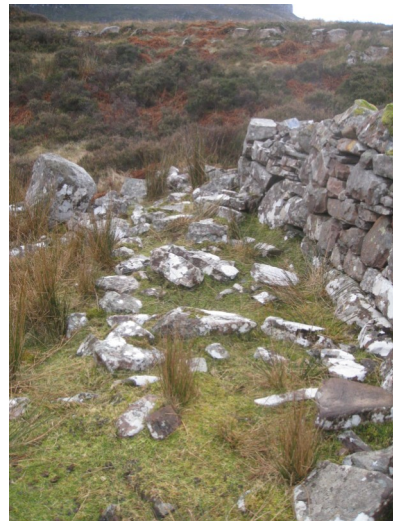
12. cont

12. A ruin with its rear wall built into the slope. It has a definite entrance, and the walls are well constructed with layered chosen stones. In front of the ruin is a stone pathway, and there is a platform built out from the path. A possible house. NG 82512 54728 elevation 30m

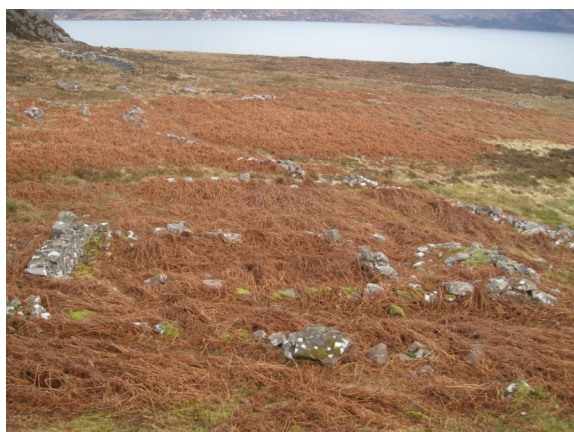
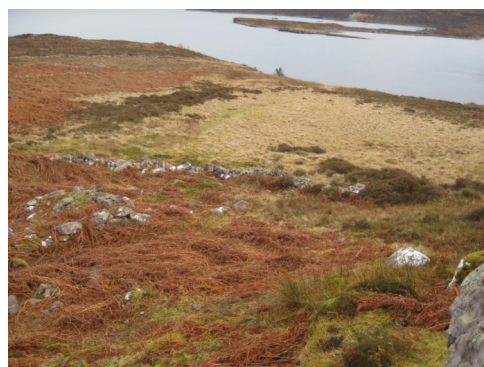
13. Ruin of a two compartment building with an enclosure attached at each end of the building. There is an add on uphill of the main ruin with its rear wall built into the slope. NG 82497 54751 elevation 26m. A probable house with attached barn/byre.

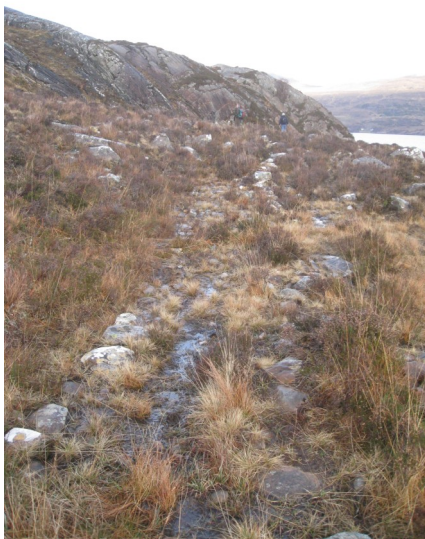
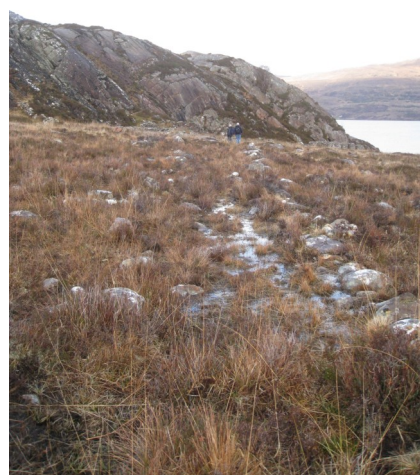
16. A stone track that leads from the iron gateway (14) in front of the fank, towards the houses at 17 and 19. NG 82534 54837 elevation 24m

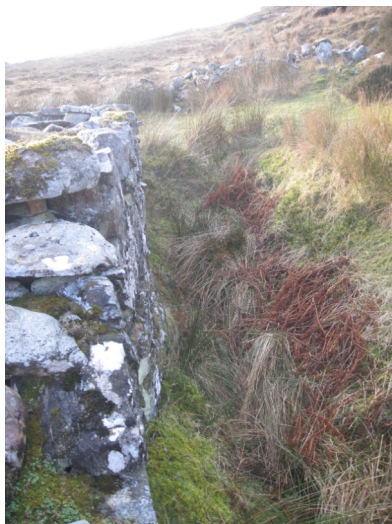
17. Ruined house with attached byre with byre drain. There are two rooms in the house. The whole building is surrounded by an enclosing wall which attaches to the crag under which the ruin lies. There is an E facing doorway and a window still evident, but no chimney. A ditch runs the length of the building to remove runoff from the crag .NG 82540 54903 elevation 23m.

A few metres uphill from the ruin are the footings of a small building NG 82540 54903 Elevation 23m

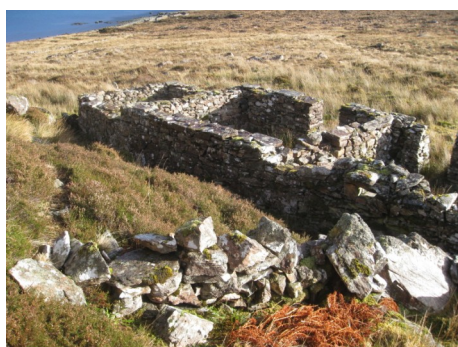
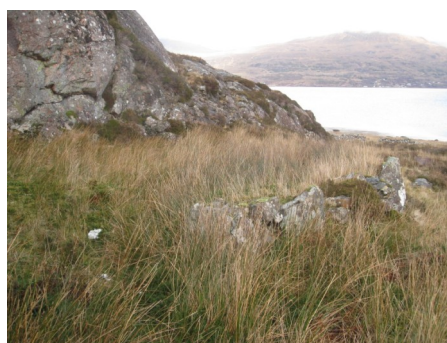
19. cont

In front of the house the drain containing the runoff from the adjacent well at 18 has a stone slab bridge over it and this drain continues on down slope towards the sea. There is a stone path in front of the building.

The building is well made with chosen and dressed stone that is layered. It has rounded corners and no evidence of a chimney, but a door and two windows. The main building has an added dividing wall which had a doorway that has been closed up. There is a cruck slot in one wall. A later byre with drain has been attached to the building and beyond this there is a terraced area.

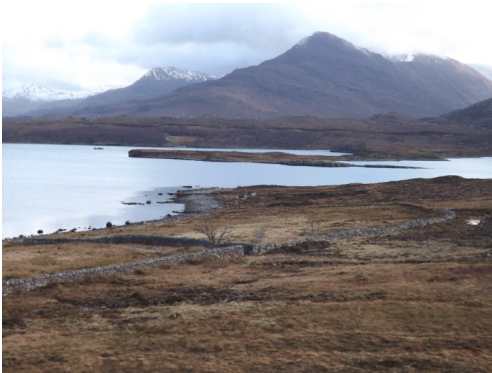
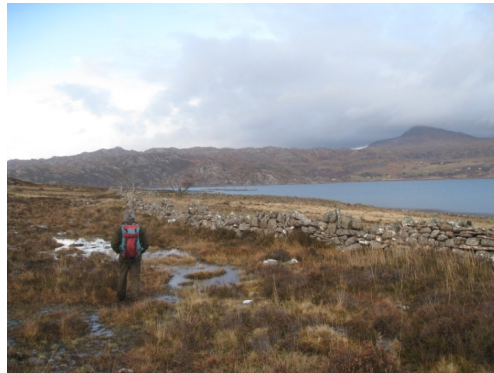
20. To the NW of these are the substantial walls of two enclosures which are accessed by a gateway NG 82616 54991 elevation 8m.

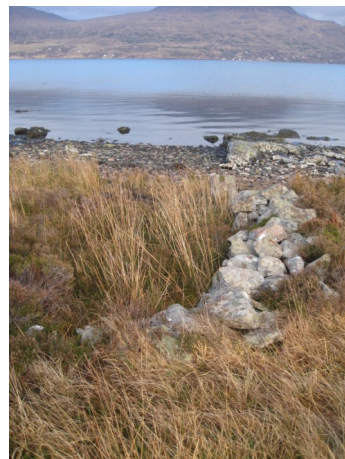
21. A stone jetty on the shore beside the fishing bothies. NG 82719 54996 elevation 4m

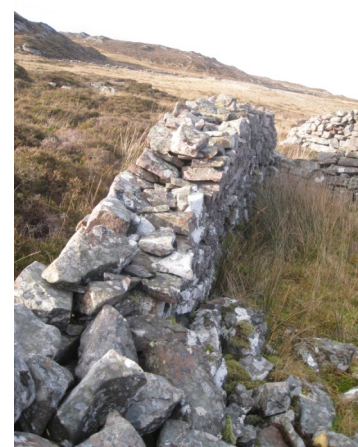
23. NG 82761 54975 elevation 3m. This second bothy is very tumbled and has a door but no windows.

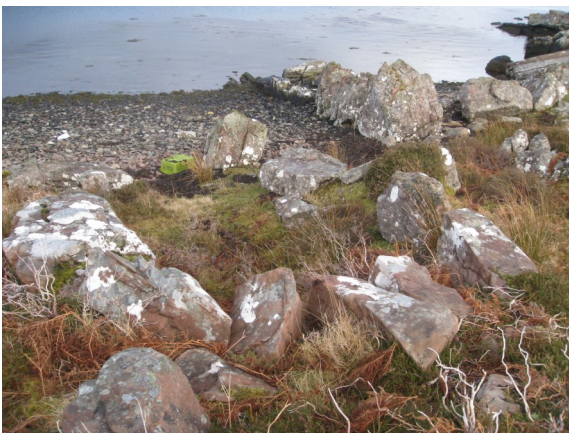
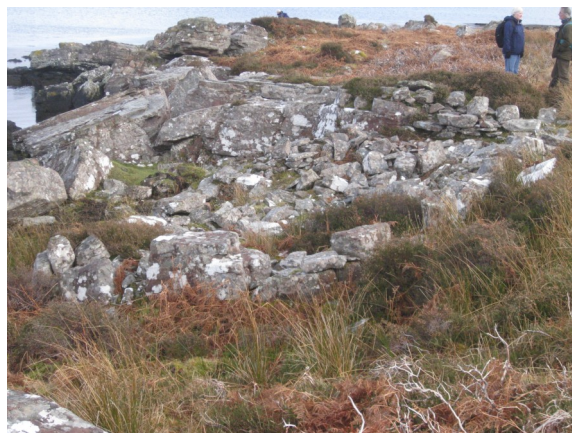
25. NG 82700 54632 elevation 3m. The ruins of a slipway and boathouse with cutting for a boat to be pulled up into.

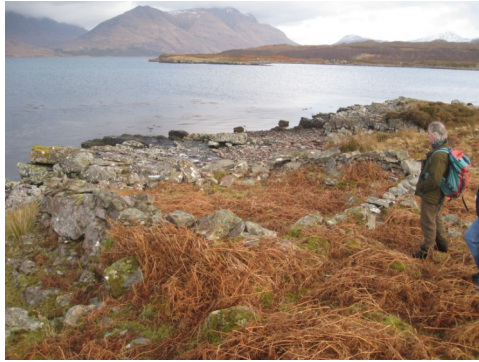
26. NG 82733 54627 elevation 4m A ruined fishing bothy by the shore with no door or window visible as walls are very broken down.

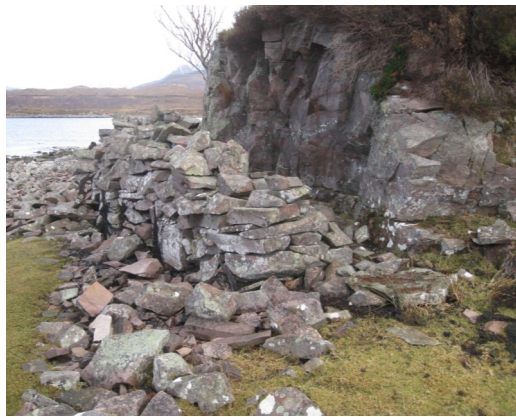
27. NG 82794 54578 elevation 3m A stone shelter or hide underneath a crag.

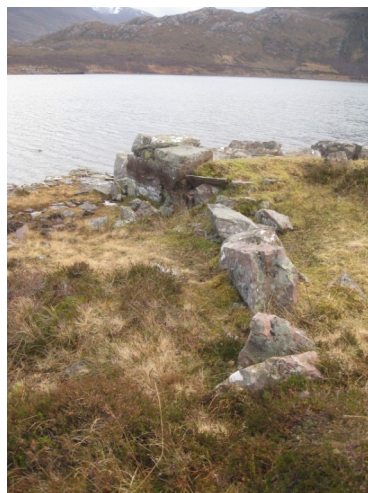
28. NG 82730 54525 elevation 3m A line of stones from top of shore rockface leading inland , purpose unknown.

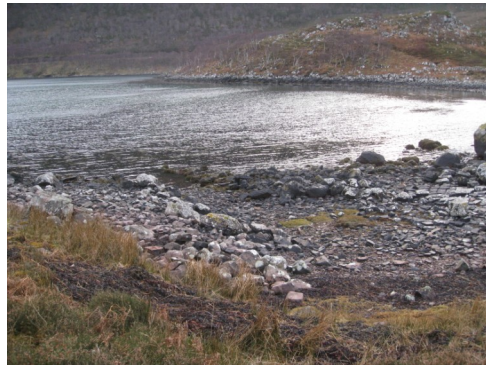
30. NG 82579 54359 elevation 3m A slipway

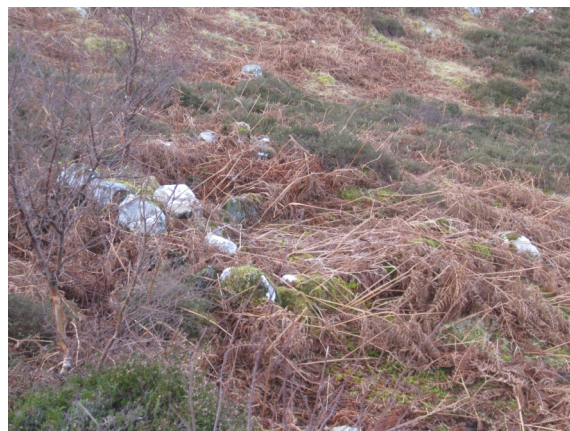
31. NG 82477 54221 elevation 9m. A terrace edged with stones

32. NG 82507 54211 elevation 12m. A small stone bothan 2x2m close to 31.
