Doire-  
chlaigionn

Centred on NG  
82575 54783

# Doire-chlaigionn centred on NG 82575 54783

This settlement is situated on an E facing slope leading down to Ob Mheallaidh on Upper Loch Torridon and to the NE of the village of Shieldaig.

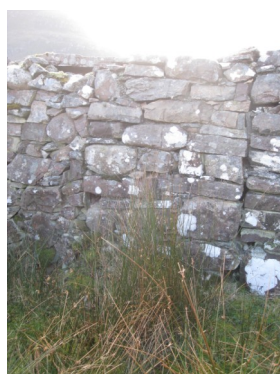
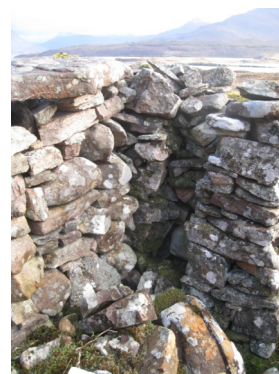
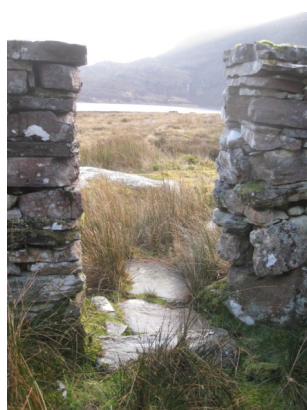
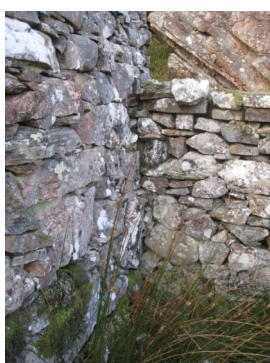
The building is well made with chosen and dressed stone that is layered. It has rounded corners and no evidence of a chimney, but a door and two windows. The main building has an added dividing wall which had a doorway that has been closed up. There is a cruck slot in one wall. A later byre with drain has been attached to the building and beyond this there is a terraced area.
